Rebuild Instructions

Xerox WorkCentre 7500-7800-7900 Series Drum Unit 013R00662

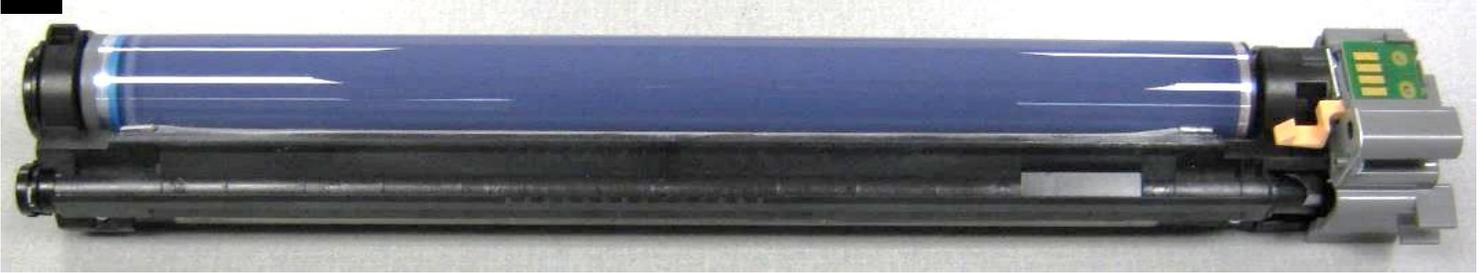
- 1** Position used drum unit on flat work surface.

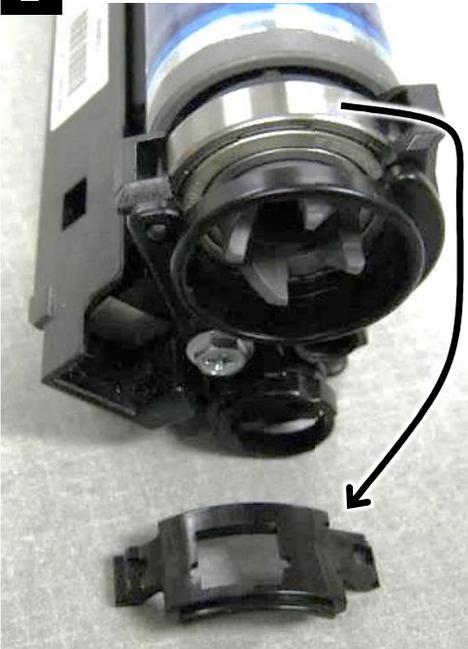
- 2** Remove rear plastic bearing cover.

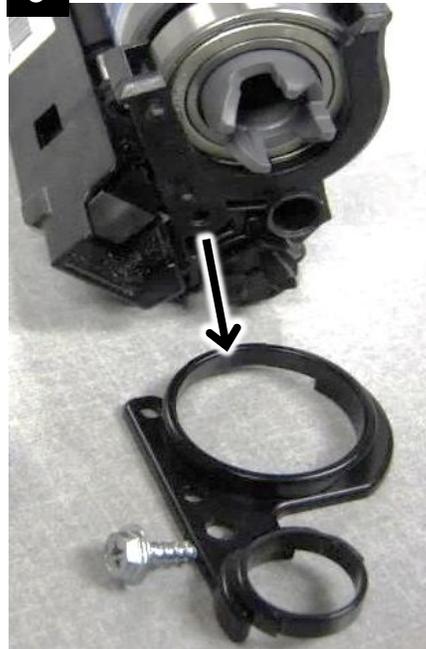
- 3** Remove the screw and rear cover.

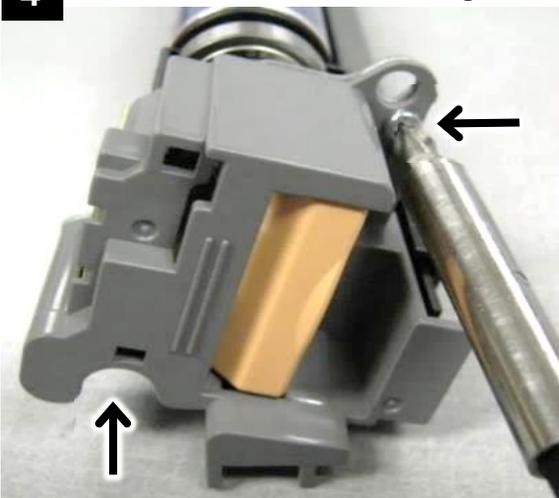
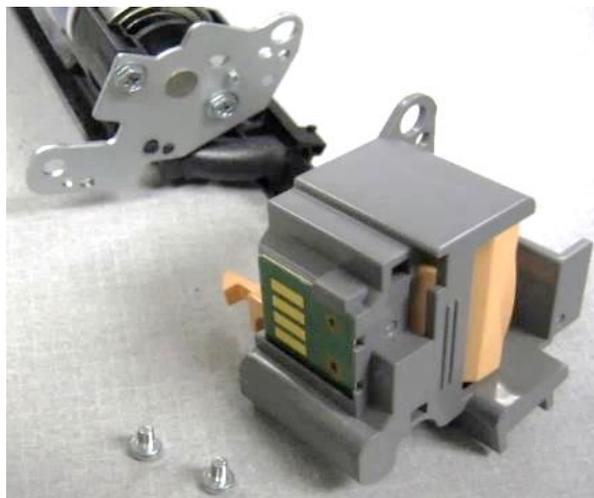
- 4** Remove the 2 screws securing the front cover and remove the front cover.

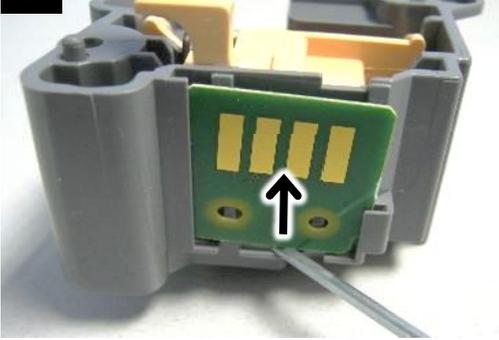
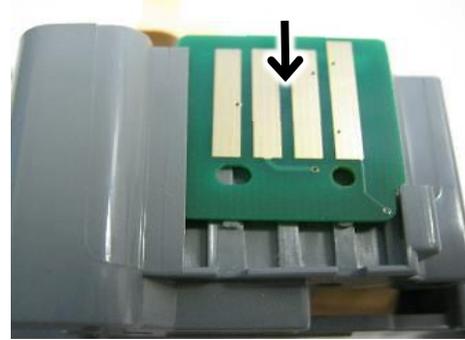
5 Remove the old chip from the front cover. Install the new chip into position on the front cover.

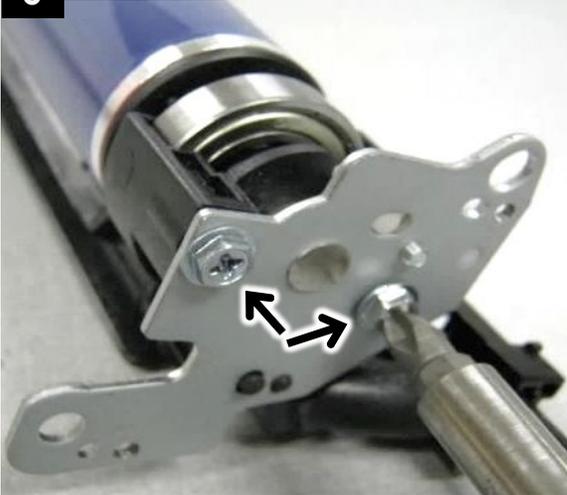
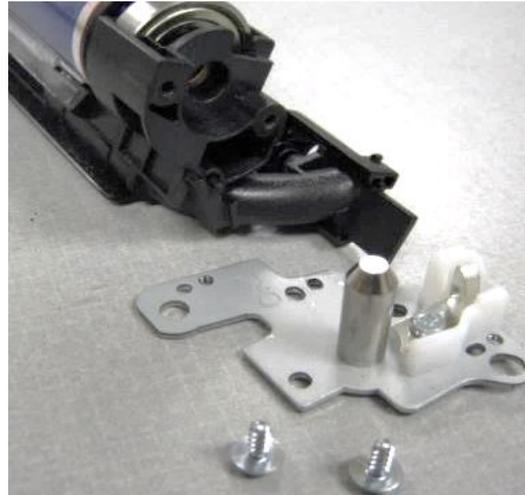
6 Remove the 2 screws securing the front retaining pin bracket and remove the bracket.

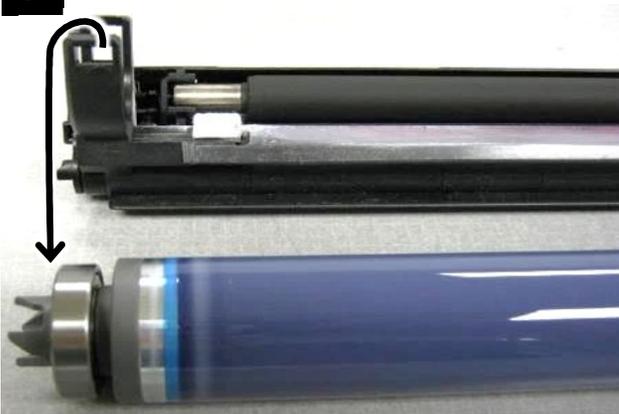
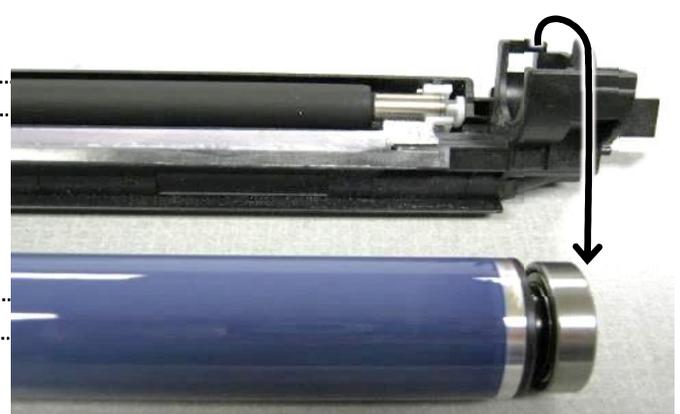
7 Lift up on both ends of the used OPC drum to remove it from the drum unit frame.

Charge Roller
OPC Drum

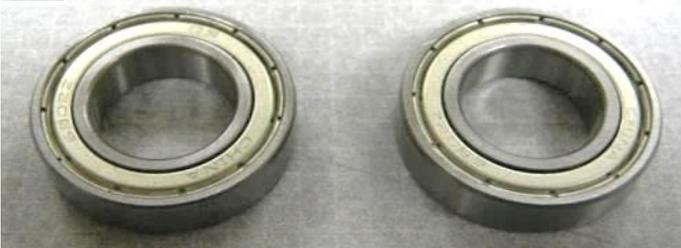
8 Remove the 2 bearings from the used OPC drum and set aside.

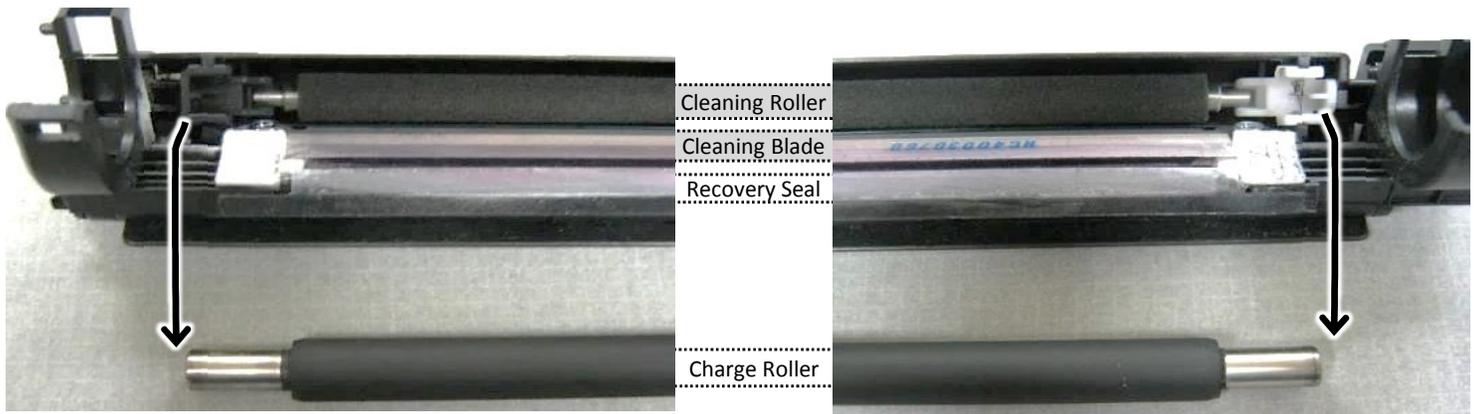
- 9** Remove and clean the charge roller using the cleaning wipe provided in the kit. Remove and clean the foam charge roller cleaning roller. Set both parts aside.

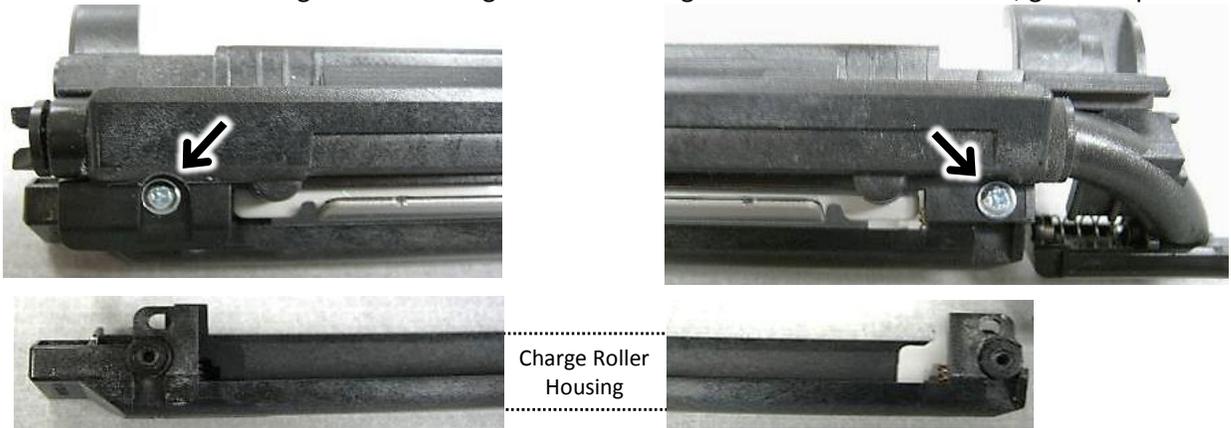
- 10** If replacing the drum cleaning blade, remove the 2 screws securing the plastic charge roller housing to the drum unit frame and remove the charge roller housing. Set the housing and 2 screws aside. If not, go to Step 13.

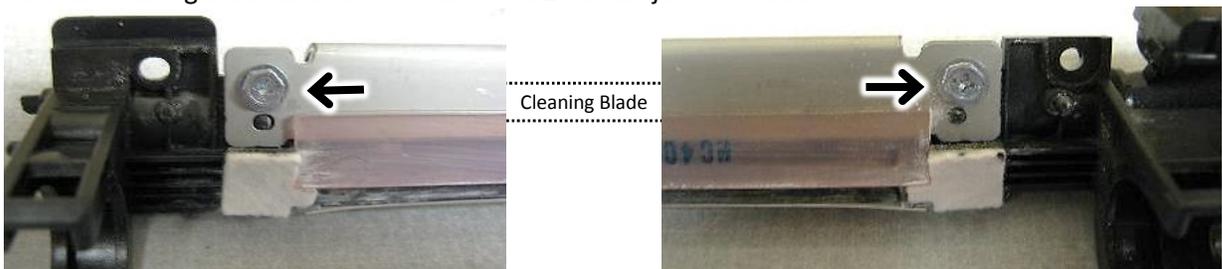
- 11** Remove the 2 screws securing the old drum cleaning blade and remove the old cleaning blade. Install the new cleaning blade and secure it with the 2 screws just removed.

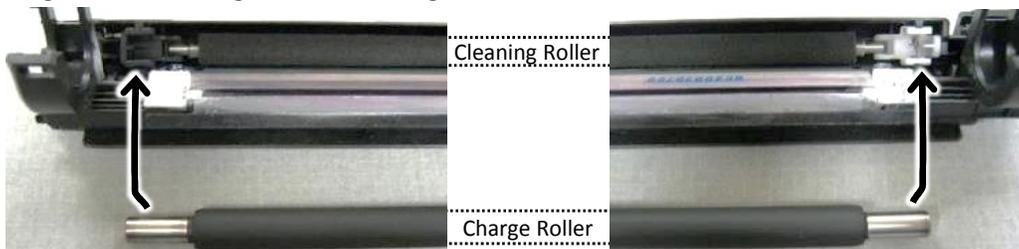
- 13** Install the charge roller cleaning roller and charge roller into the drum unit.

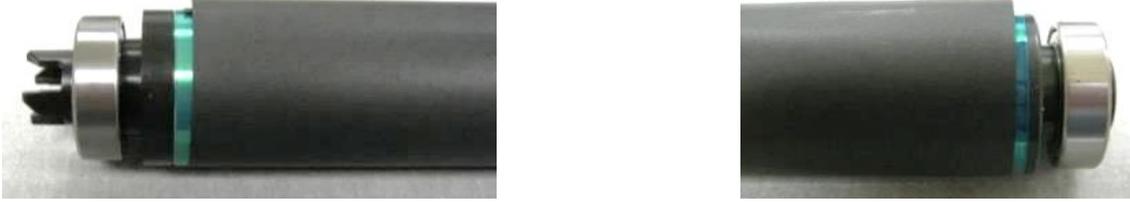
14 Install the 2 bearings removed during step 8 on the new OPC drum.

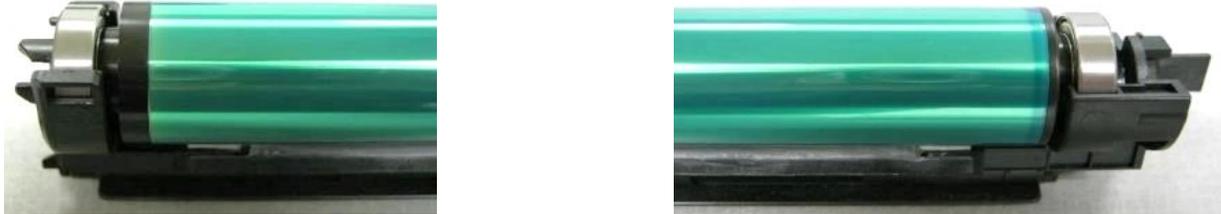
15 Remove the black wrap from the new OPC drum and install it into the drum unit frame.

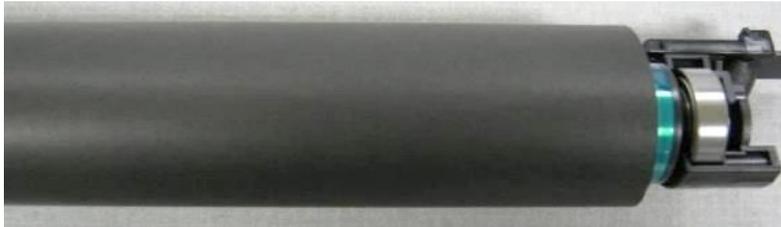
16 Cover the new OPC drum with the black wrap removed during step 15 (protect it from light exposure).

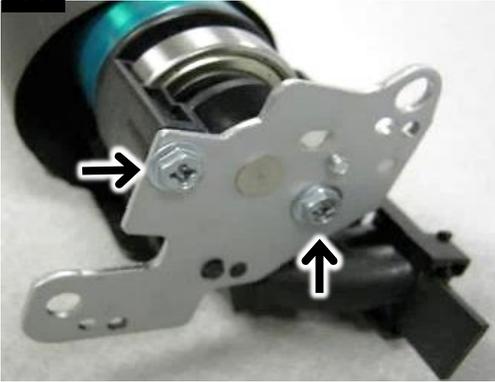
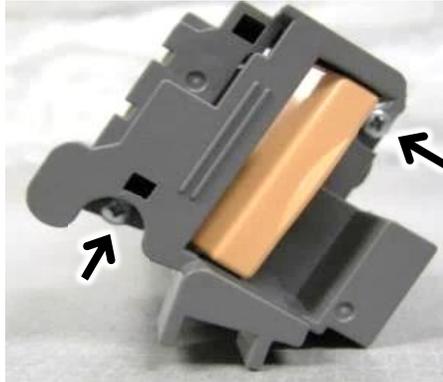
17 Install and secure the retaining pin bracket and front cover removed during step 6 and step 4.

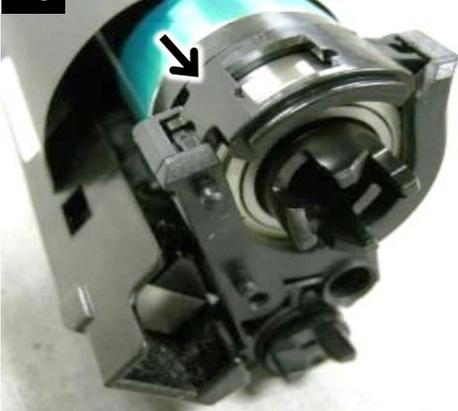
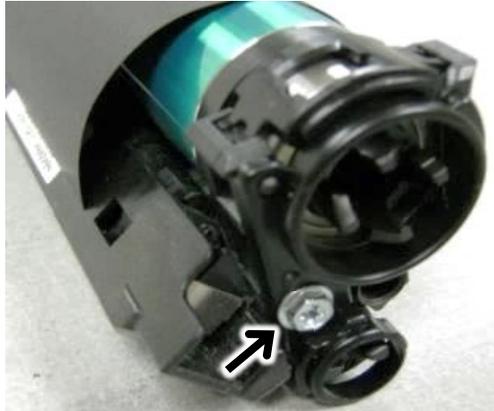
18 Reattach and secure the rear bearing cover and the rear cover removed during step 2 and step 3.
