Straight Talk on Parts

Topic: Recoated Fuser Rollers

Revised February 1997

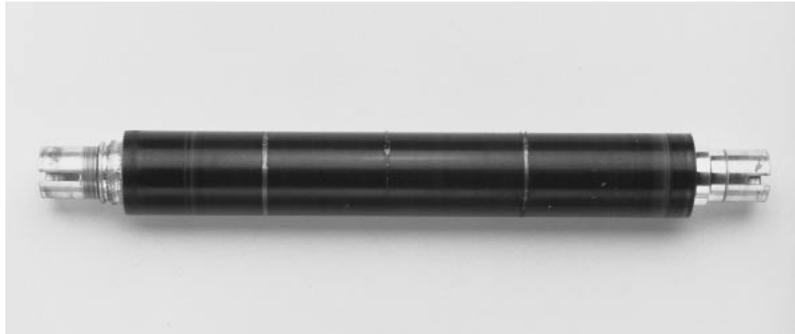
Figure 1. Although this used fuser roller looks as though it could be recoated to provide satisfactory performance, closer inspection will reveal otherwise.

1. During removal from machines, temporary storage, and shipping (often without sufficiently protective packaging), used fuser rollers commonly incur damaged gear slots, damaged or weakened end journals, and severe scratches or dents (see Figures 1 - 3 on next page). Although such defects can lead to performance problems ranging from frequent paper jams and poor fusing to parts seizure resulting in catastrophic fuser station failure, recoaters generally don’t take the steps or have the sophisticated equipment necessary to detect

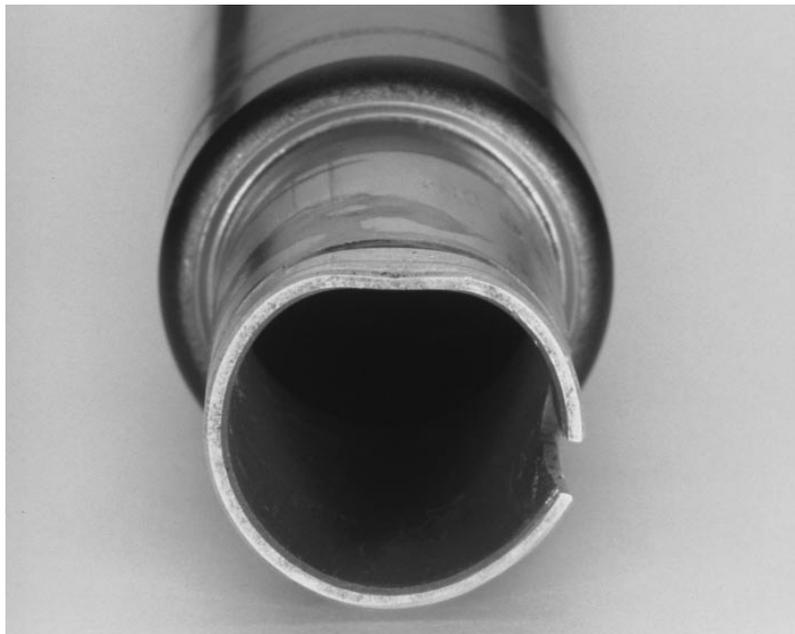
Figure 3. In addition to exhibiting surface abrasion sufficient to cause performance problems, the end journal on this used fuser roller is severely dented and “out-of-round.” *This type of physical damage to end journals frequently causes premature bearing seizure, which can result in catastrophic damage to the fuser station and related parts.*
