Canon imageRUNNER/iR Advance C5030/C5045

Color Drum Removal/Installation

Canon imageRUNNER/iR Advance C5030/ C5045-series Universal Color Drum

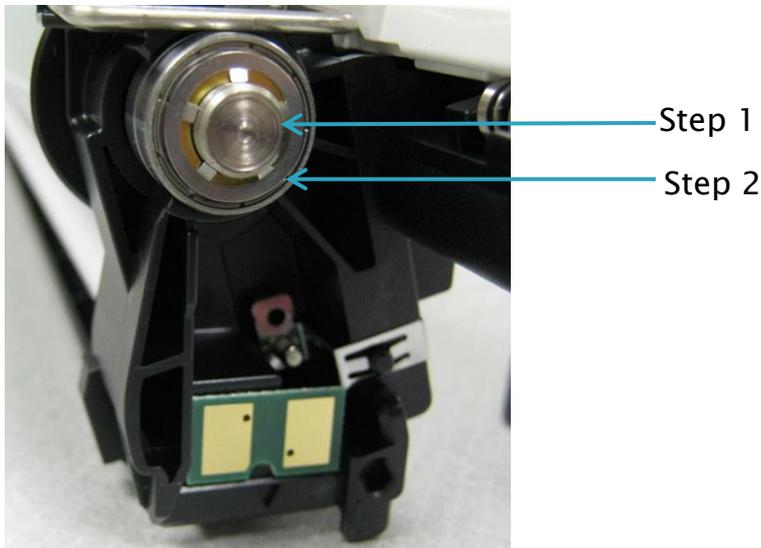
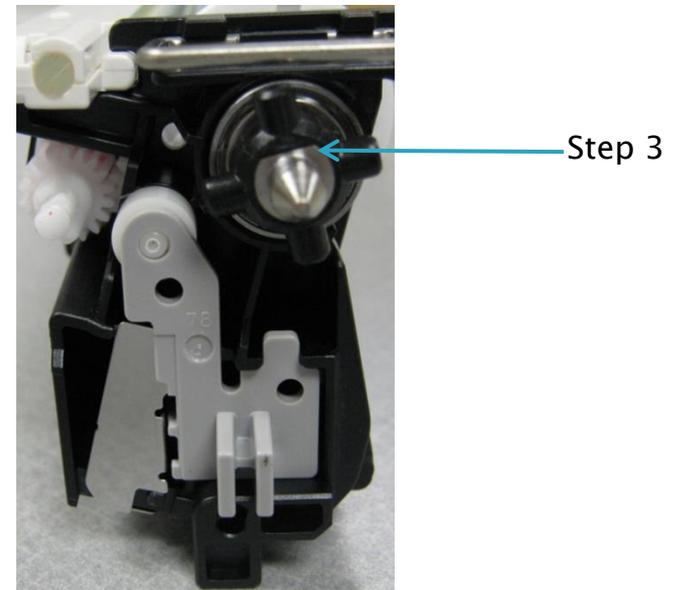
- ▶ Technician removal/replacement time < 5 minutes
- ▶ Easy Drum Removal (3 step process):
 - Step 1: Remove the grip ring from the OPC drum shaft
 - Step 2: Remove one outer bearing from the OPC drum shaft
 - Step 3: From the opposite end of the drum unit, remove/slide the drum shaft out from the drum unit to release the OPC drum

- ▶ Easy Drum Replacement (3 step reverse process):
 - Step 1: Position new Katun drum (PN 44336) in drum unit and slide in the OPC drum shaft
 - Step 2: Attach the outer bearing to the OPC drum shaft
 - Step 3: Attach the grip ring to the OPC drum shaft
- ▶ OEM drum cleaning blade can be used for 2–3 Katun color drum replacement cycles and continue to provide excellent performance because.....
 - OEM black drum units use a cleaning blade with the same basic geometry and materials as the OEM color drum unit
 - OEM black drum unit has almost 3X the stated life of the color drum unit
 - OEM black drum unit has a long-life Canon e-drum coating that can exceed the stated life and go beyond 200K copies/prints
